Cullercoats Beach Steps Tynemouth

Case Study

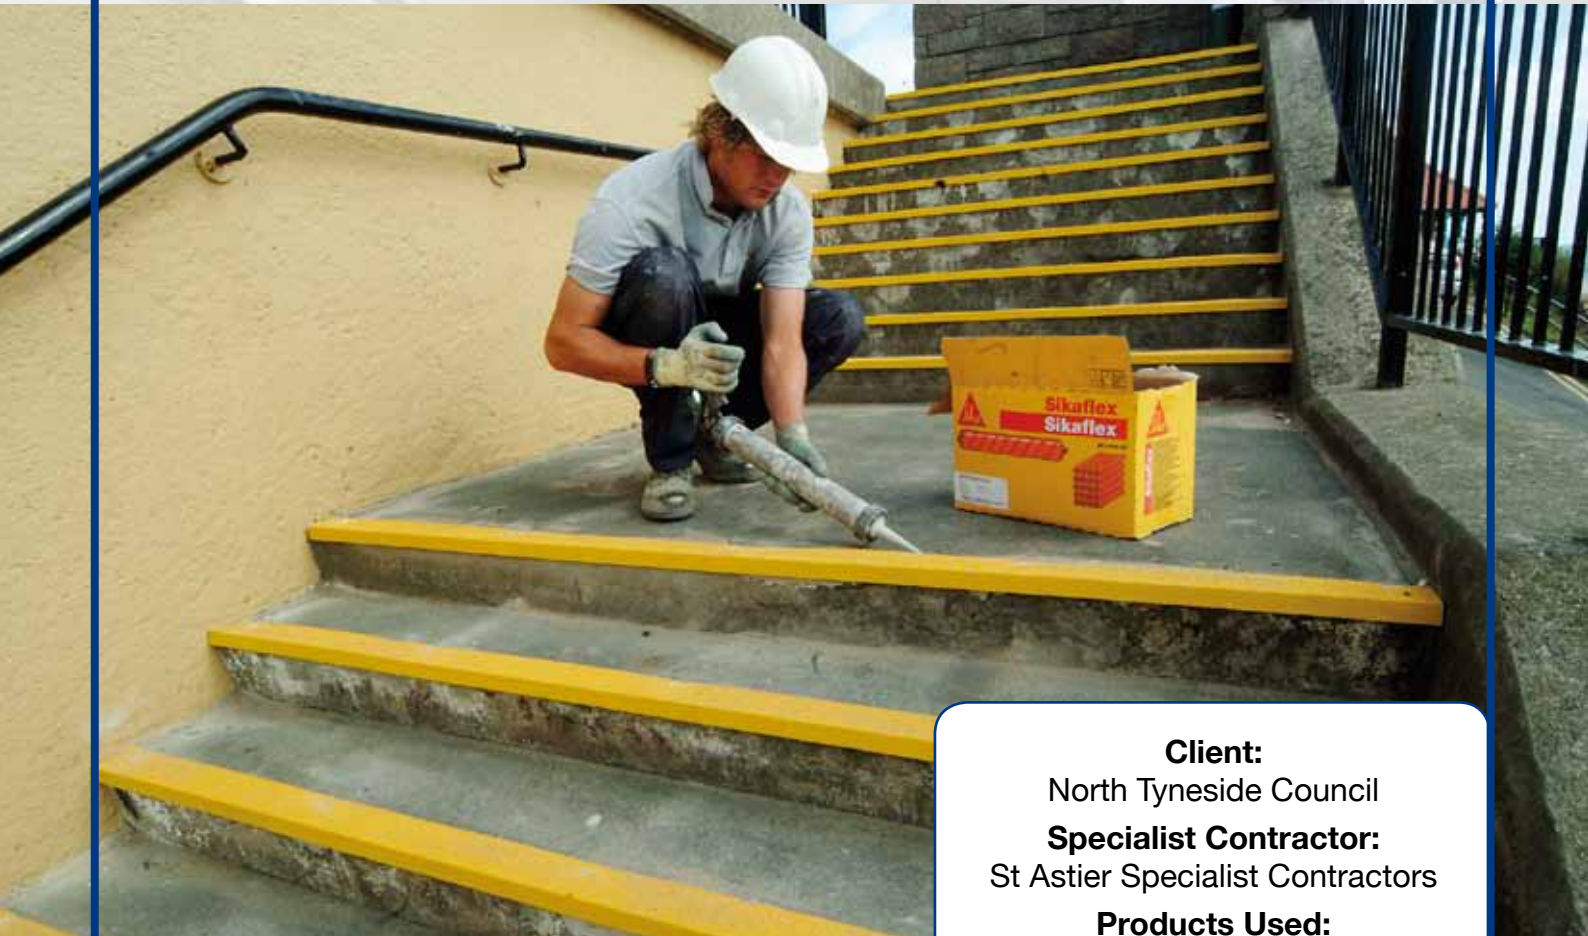
Over time, the public access steps down to Cullercoats Beach in Tynemouth had deteriorated due to wear and their marine exposure, and this was giving North Tyneside Council concerns for public safety. Therefore St Astier Specialist Contractors were appointed to undertake repairs with an overall refurbishment and upgrading of the steps. Together with their specialist materials supplier NCC, the engineers from St Astier developed the ideal repair and upgrading system as follows:

Firstly, the concrete steps were thoroughly cleaned by water-jetting and any deteriorated or damaged concrete areas were broken out mechanically. These areas of the step risers and treads were then repaired to their original line and profile, with a high strength, fast-setting Sikadur epoxy repair mortar.

Finally, to improve safety and enhance slip resistance, special preformed, non-slip nosings from Ronacrete, were mechanically fixed and sealed onto the front of each step. These high visibility, bright yellow profiles, were mechanically fixed, as well as being bonded and sealed in position to prevent any lateral movement or future water underflow. This sealing was achieved using a Sikaflex waterproof adhesive sealant, based on polyurethane (PU) with permanent elasticity and recovery to help accommodate traffic and thermal movement.
