Schaars Meat Processing Plant, Bad Lahr, Germany

Case Study

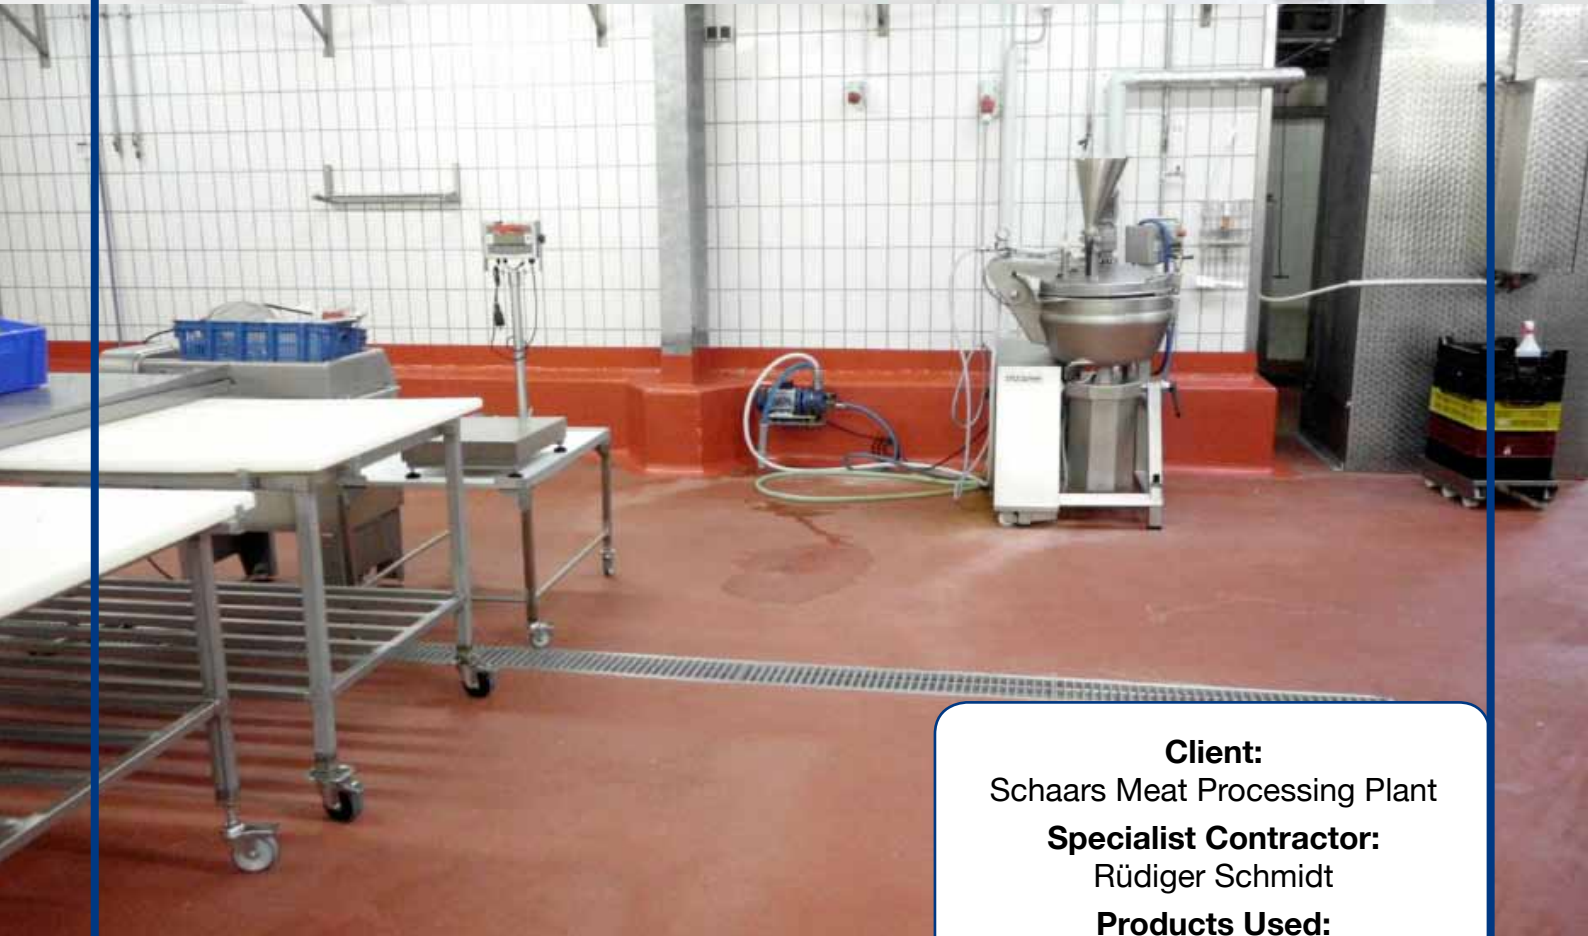
This catering butchers and meat processing factory in Bad Lahr, Northern Germany, was having problems with damaged and worn floors in an area requiring approval for use in contact with foodstuffs. This was due to the heavy equipment with abrasive pallet trucks and small wheeled containers used extensively around the plant. The plant had previously tried standard epoxy resin based floor coatings, but they had not given the length of service they were looking for in this high wear environment, where the exposure is also exacerbated by frequent hot water and steam cleaning with additional detergents.

Specialist Contractors, Rüdiger Schmidt GmbH, were asked for advice and they proposed a complete floor repair and high build coating solution, using a VIP 2-component, hot-spray applied, polyurea resin system. This VIP polyurea system is used for highly abrasion and chemically resistant floors, including the incorporation of ballotini glass beads to achieve the level of anti-slip resistance (Class R11), which defines that the surface is suitable for wet food process environments.
